**NASA Contractor Report 178409**

## **Composite Transport Wing Technology Development**

Douglas Aircraft Company  
McDonnell Douglas Corporation  
Long Beach, CA 90846

**Contract NAS1-17970  
February 1988**

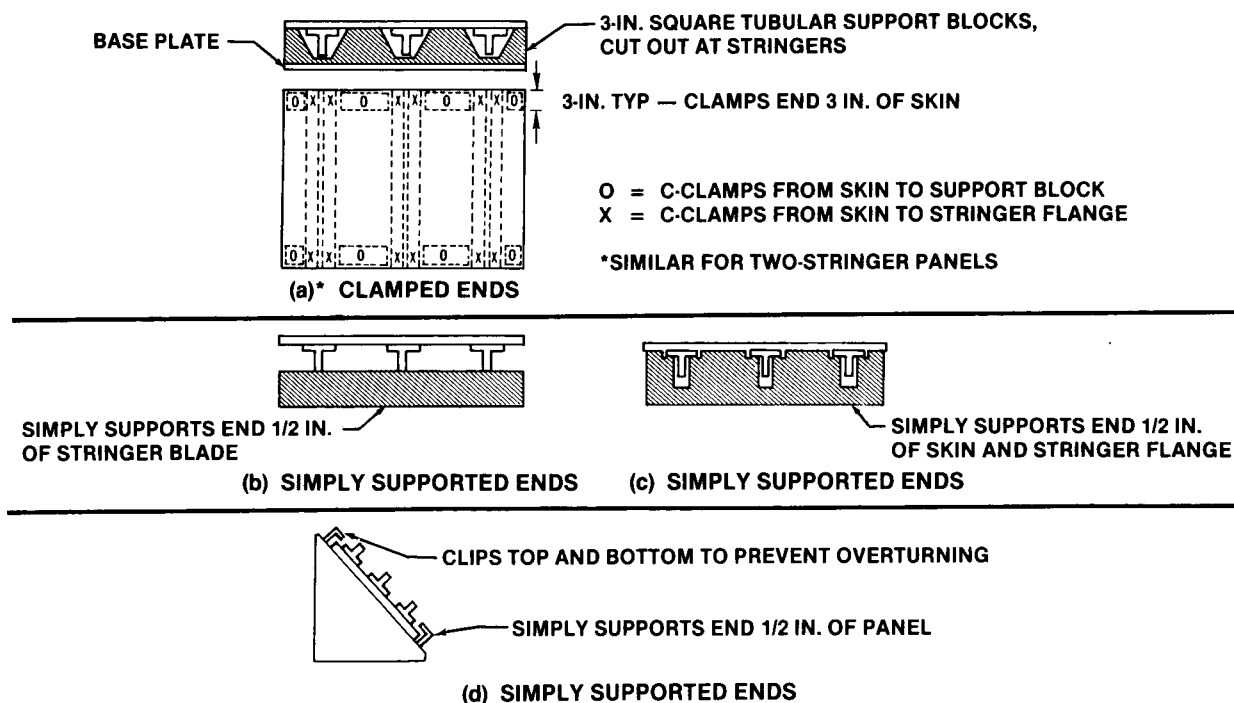
Figure 24. Support Conditions for Impact Tests

The development tests concentrated on three areas. The first test in this group involved impacting two-stringer panels at midbay, stringer flange, stringer blade, and laterally on the stringer blade. These panels were impacted at various energy levels ranging from 20 to 100 ft-lb. After impact damage was inflicted, the panels were nondestructively inspected to determine the severity of damage. The results were used to determine the amount of impact to be applied to three-stringer panels. All of these panels were supported at their opposite edges similar to the configuration shown in Figure 24a.

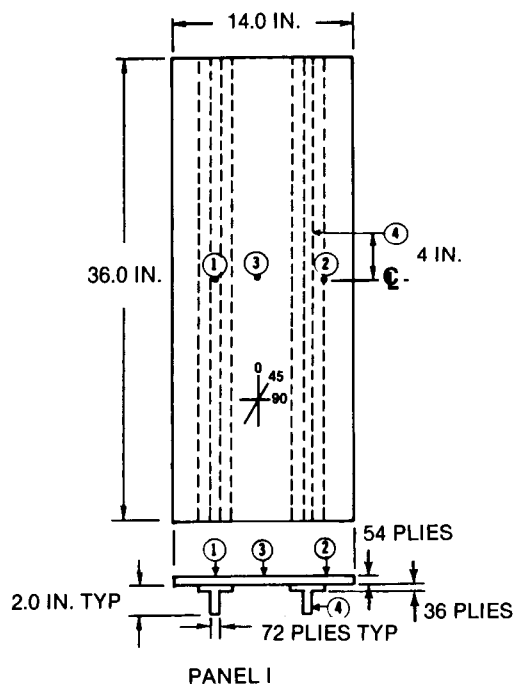
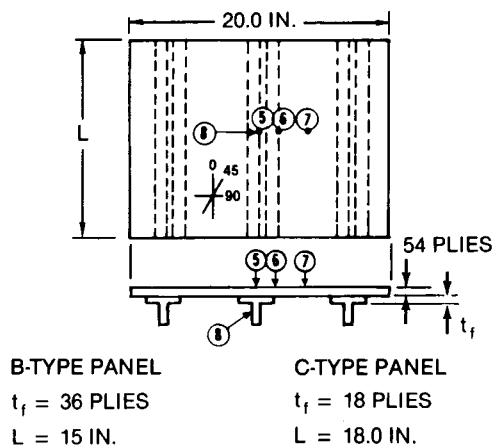
135.6 N-m (100 FT-LB) IMPACT LOCATIONS	
1. OVER BLADE	2-STRINGER PANELS
2. OVER FLANGE EDGE	2-STRINGER PANELS
3. MIDBAY	2-STRINGER PANELS
4. LATERAL BLADE	2-STRINGER PANELS
5. OVER BLADE	3-STRINGER PANELS
6. OVER FLANGE EDGE	3-STRINGER PANELS
7. MIDBAY	3-STRINGER PANELS
8. 45-DEG LATERAL BLADE	3-STRINGER PANELS
ALL SKIN AND STRINGER LAY-UPS [0/45/0/- 45/0/45/0/- 45/90] <sub>n</sub> (SYM)

Figure 25. Impact Panel Configurations and Impact Locations

The impact locations of two- and three-stringer panels are shown in Figure 25. The structural test plan was drafted with NASA consultation to test three-stringer damage tolerance panels after they were impact-damaged with 100 ft-lb of energy at different locations. One of the panels was impacted with 200 ft-lb of energy, which resulted in visible damage.

Locations for external skin impacts were midbay between stringers, over the blade, and over the stringer flange edge. Internal impact tests were applied laterally on the stringer blade. Tables 9 through 11 describe each test individually, while Figures 16, 24, and 25 detail the associated impact locations and test boundary conditions.

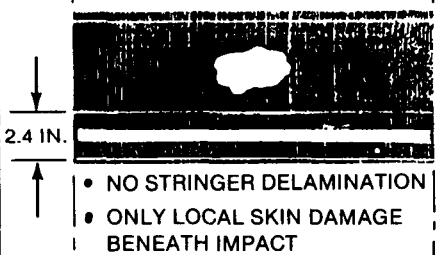
C2	3-STRINGER, 18-PLY FLANGE	7 MIDBAY IMPACT	C SIMPLE SUPPORT

<ul style="list-style-type: none"> <li>• NO STRINGER DELAMINATION</li> <li>• ONLY LOCAL SKIN DAMAGE BENEATH IMPACT</li> </ul>
C4	3-STRINGER, 18-PLY FLANGE	8 45-DEG LATERAL BLADE IMPACT	D SIMPLE SUPPORT

Four three-stringer C-type specimens (Table 11) were impact-tested, and the damage status of the panels was as follows:

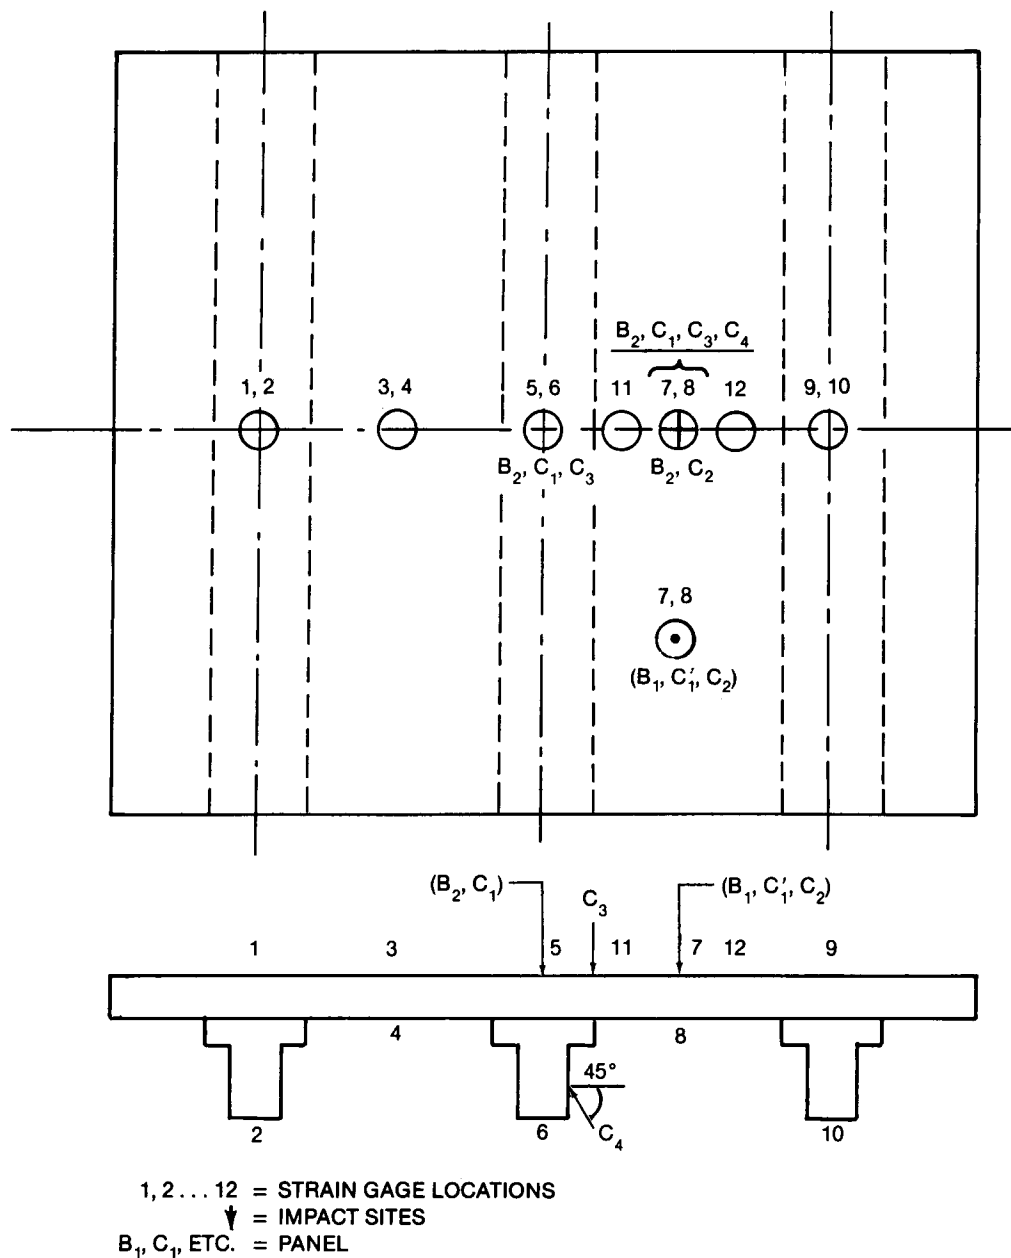
**Figure 26. Strain Gage and Impact Locations on Panels**

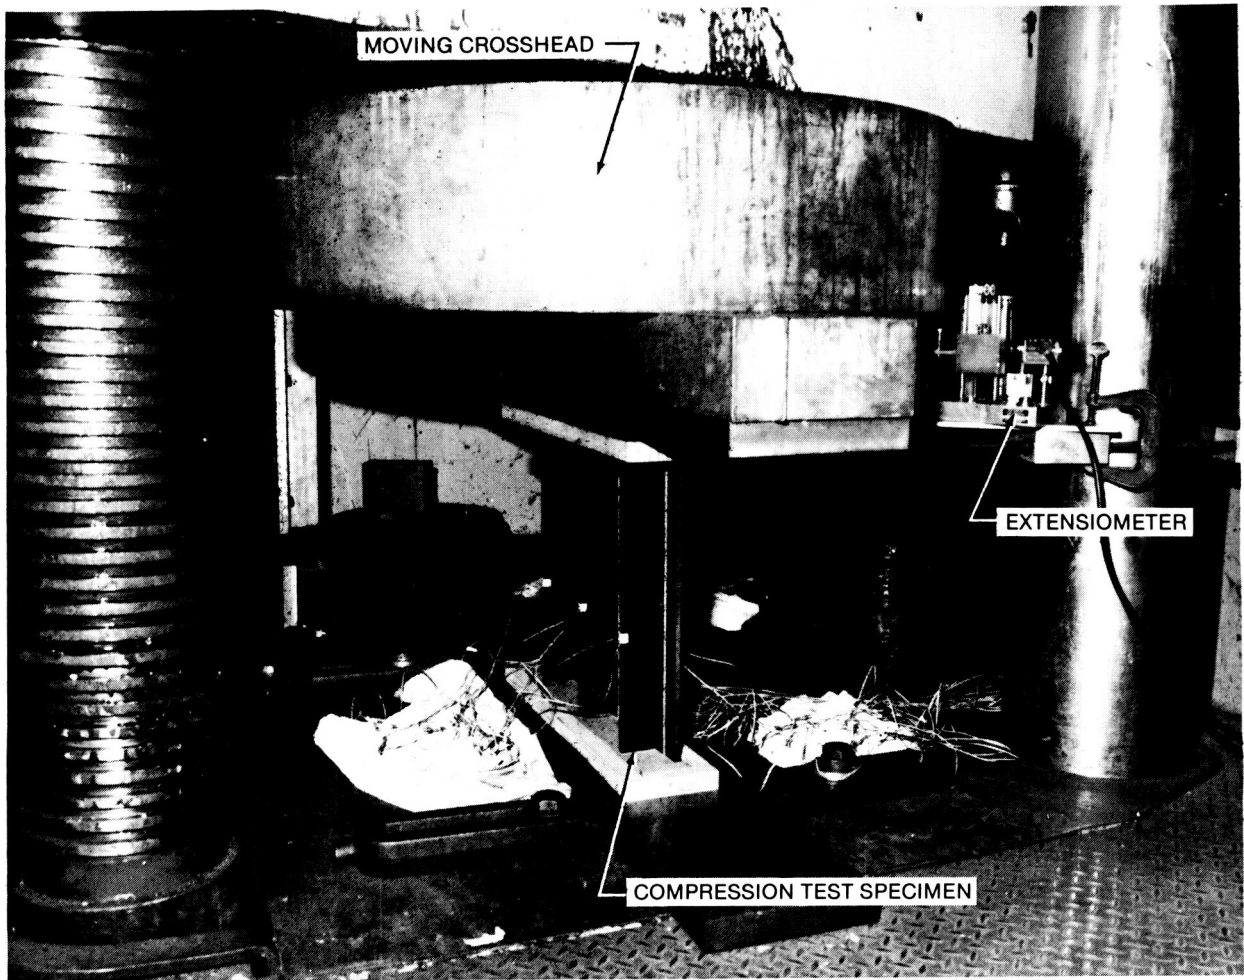
**Figure 27. Compression Test Setup**

The tests for six three-stringer damage tolerance screening specimens were conducted in the Baldwin test machine (Figure 27) with its capacity of 1.1 million pounds and by uniform end shortening at a rate of 0.02 inch per minute. The data from all strain gages were recorded simultaneously. The results are discussed in Section 5.

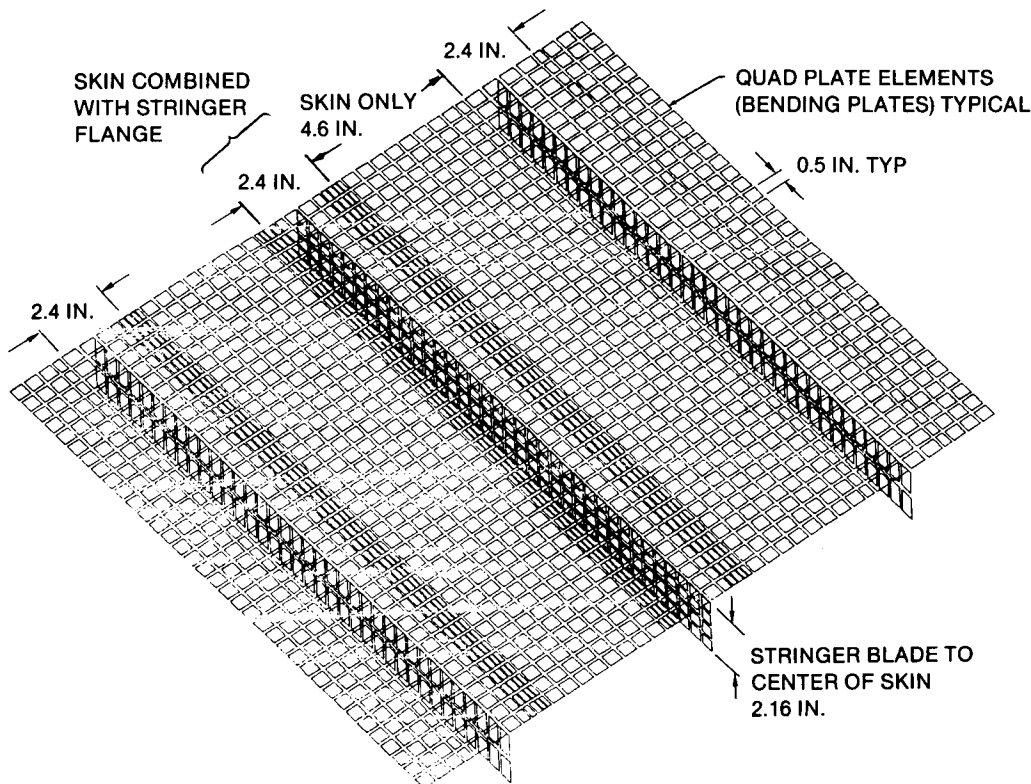
Figure 28. Typical NASTRAN Model of Impact Panels

For the case of the impact panels studied here, NASTRAN models were created to determine the resulting internal peel moments and pull-off loads. A typical model is illustrated in Figure 28 and is relatively simple. Figure 29 shows a flange edge impact NASTRAN model. The flange and skin are

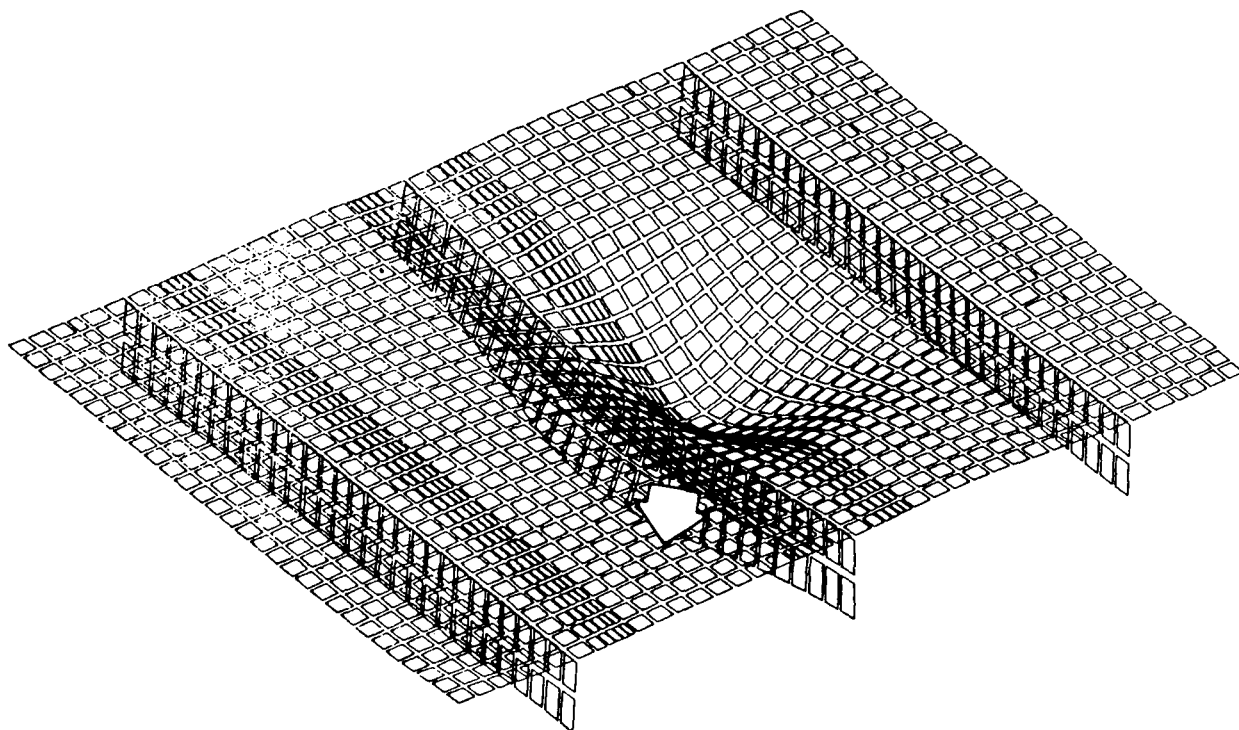
**Figure 29. NASTRAN Model Analysis for Flange Edge Impact (100 ft-lb) — See Table 10, Test ID C3**

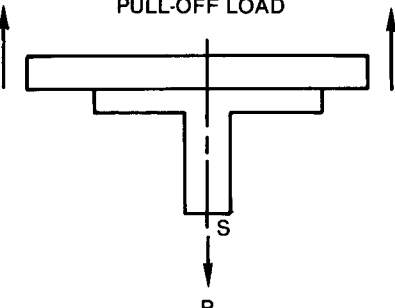
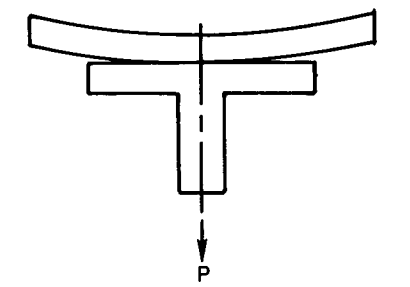
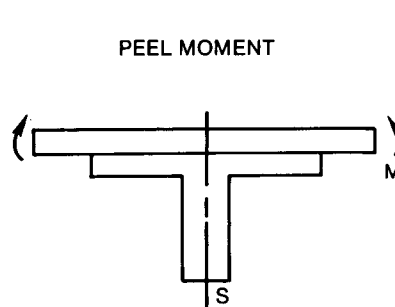
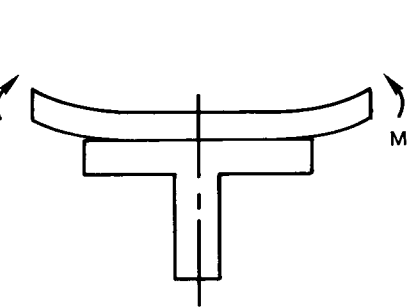
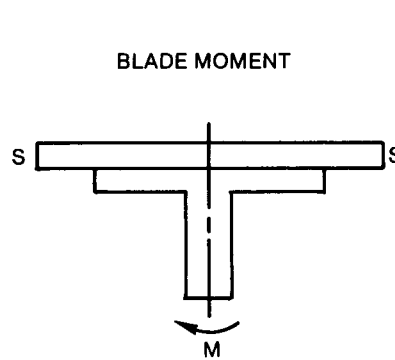
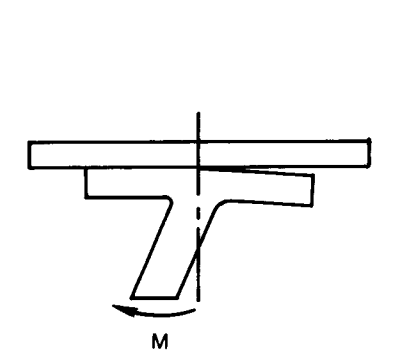
<p>HIGH INTERLAMINAR TENSION UNDER BLADE AT FLANGE EDGE</p>

<p>HIGH INTERLAMINAR TENSION AT FLANGE EDGE</p>

<p>REDUCED INTERLAMINAR TENSION AT FLANGE EDGE SINCE FLEXIBLE FLANGE ATTRACTS LESS LOAD</p>
<p>BLADE MOMENT</p>

<p>HIGH INTERLAMINAR RADIAL TENSION IN THE ELBOW</p>

<p>SIMILAR RESPONSE CAUSING RADIAL ELBOW TENSION</p>

**Figure 30. Comparison of Interlaminar Stresses in Thin (18-Ply) and Thick (36-Ply) Flange Blade Panels**

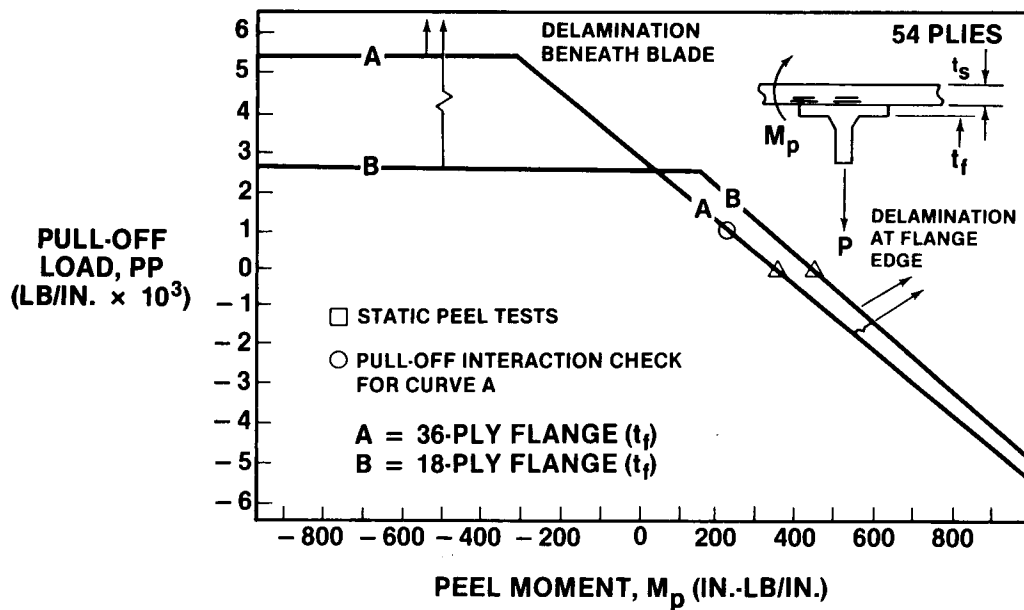
**Figure 31. Peel Moment Versus Pull-Off Load Failure Envelope for Delaminations in Skin at Stringer Interface**

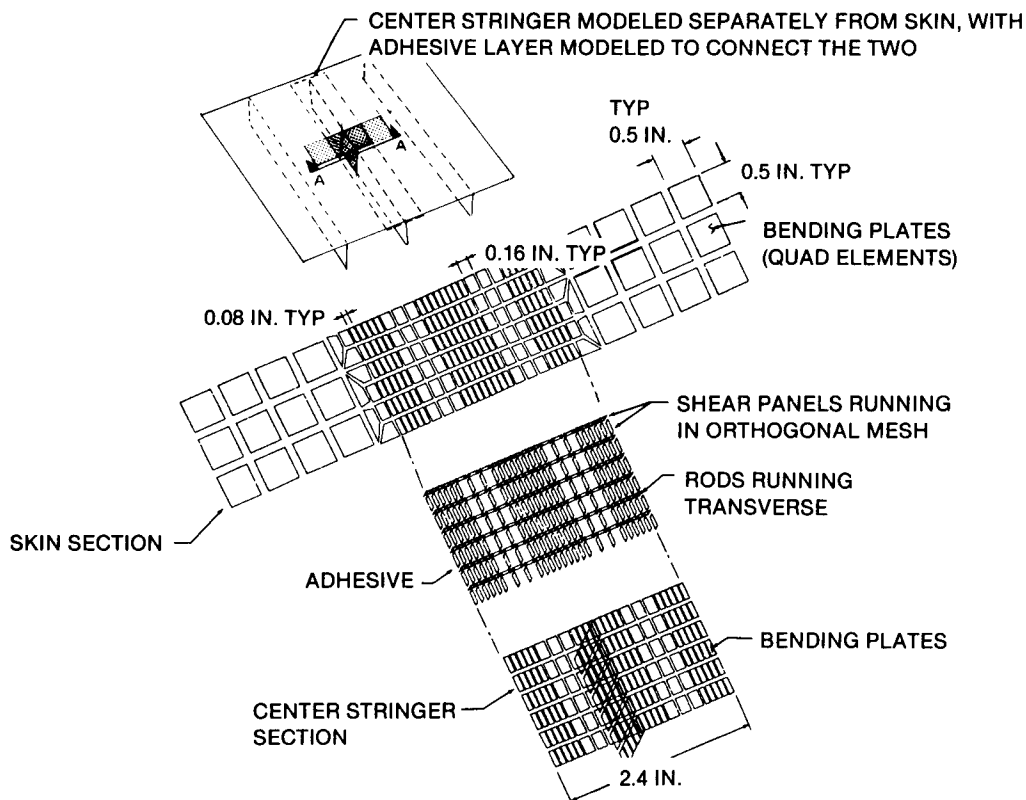
**Figure 32. NASTRAN Model with Adhesive Layer**

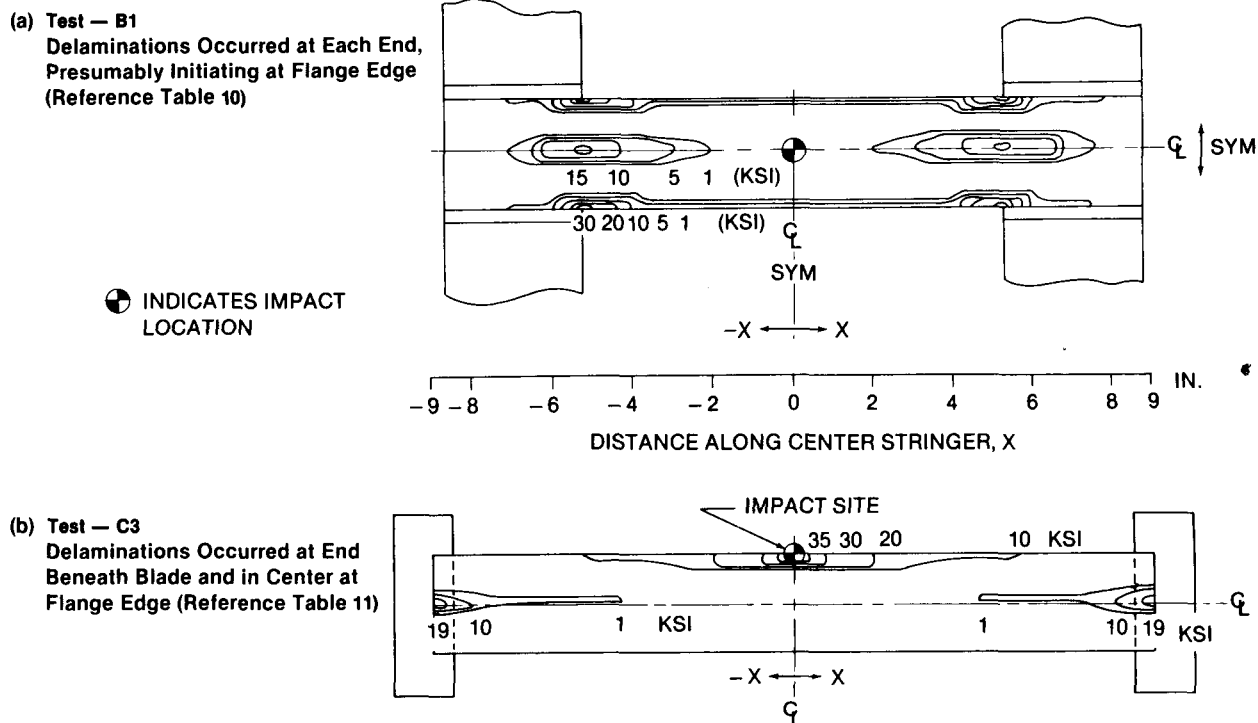
**Figure 33. Interlaminar Tensile Stress Contours Derived from Refined NASTRAN Model (Reference Figure 32)**

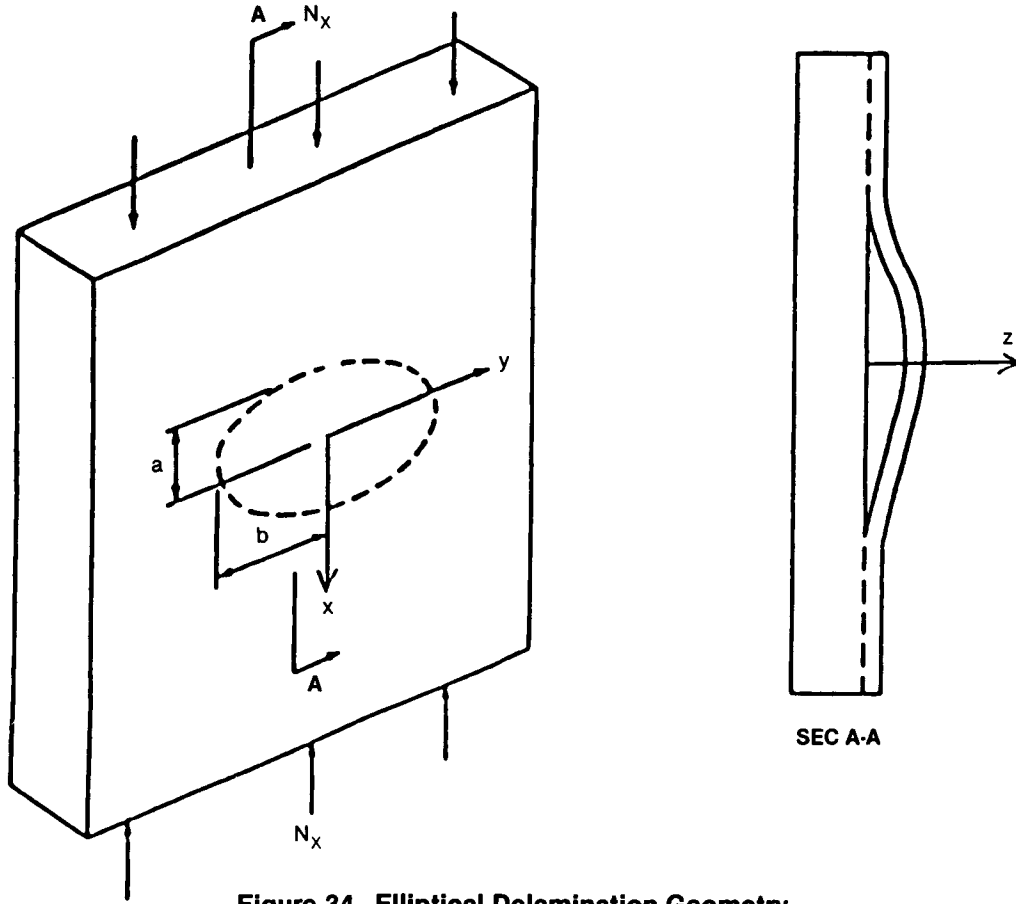
**Figure 34. Elliptical Delamination Geometry**

This work is based on a thin-film model that has a delamination with an elliptical clamped boundary (Figure 34). As the delamination grows, it maintains its elliptical shape, but with a different aspect ratio. The delamination portion of the laminate on the sublaminates is thin compared with the parent laminate;

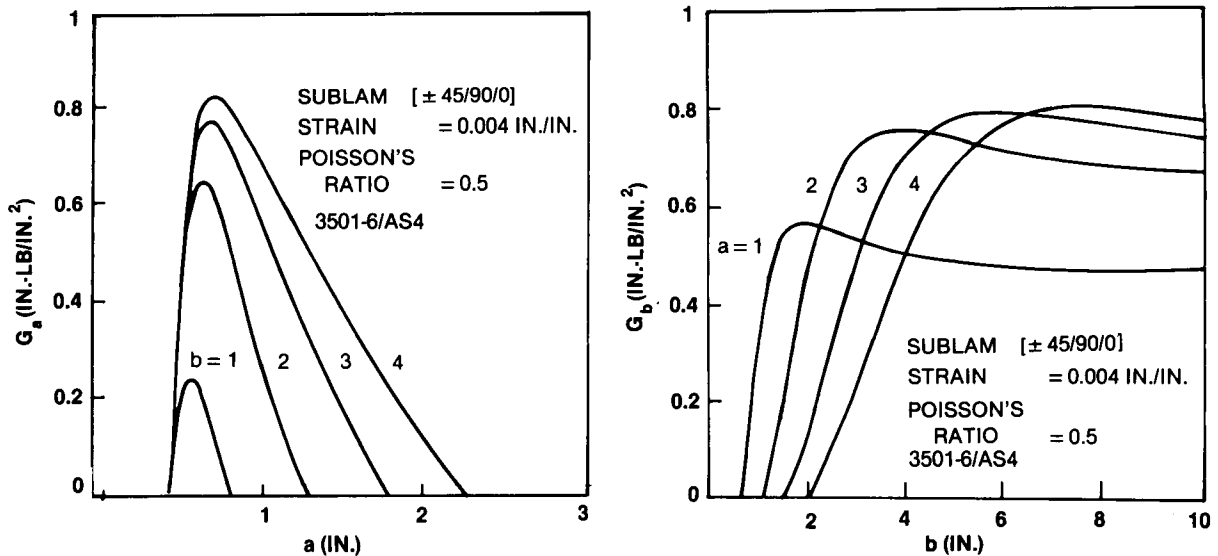
Figure 35. Variation of  $G_a$  and  $G_b$  with  $a$  and  $b$

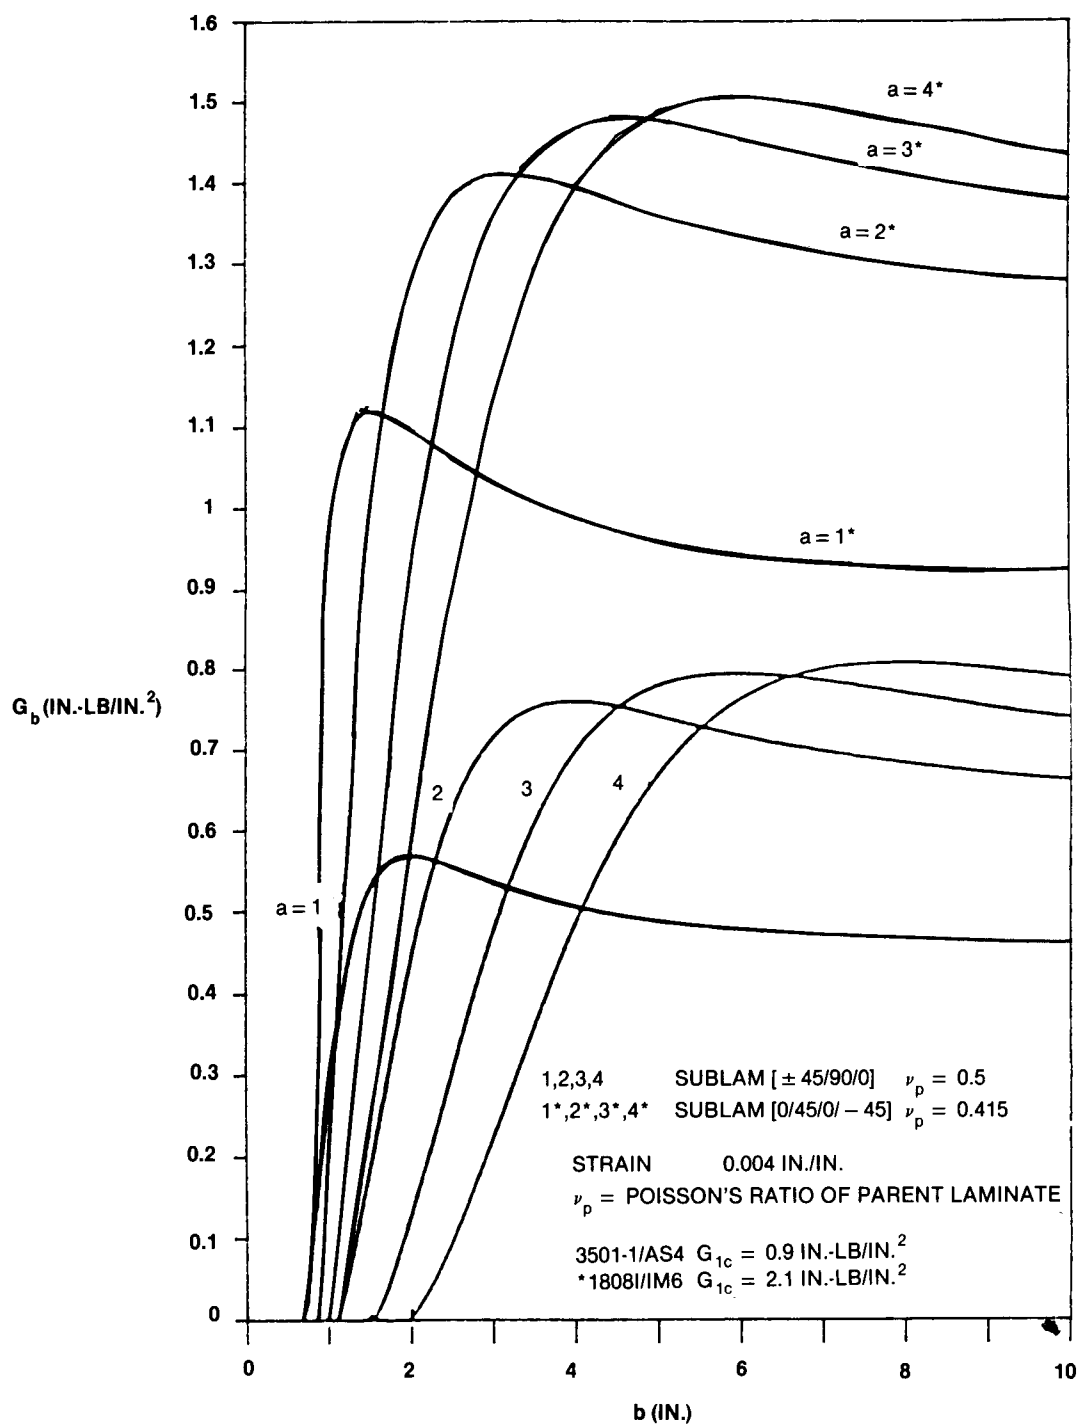
Figure 36. Sensitivity of  $G_b$  to Material Property  $G_{1c}$

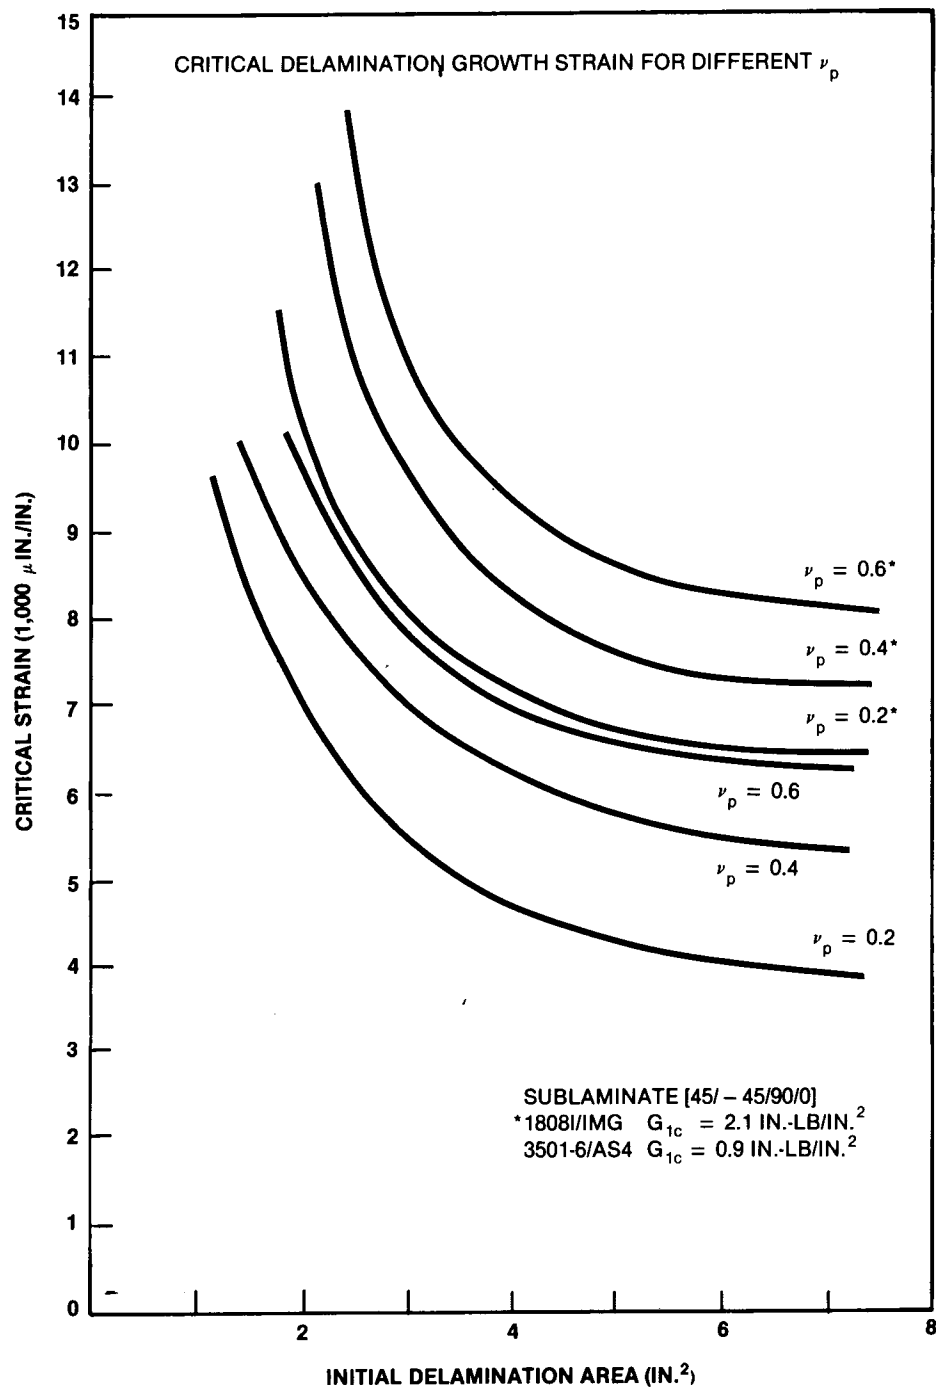
Figure 37. Sensitivity of Critical Delamination Growth Strain to the Material Property  $G_{1c}$

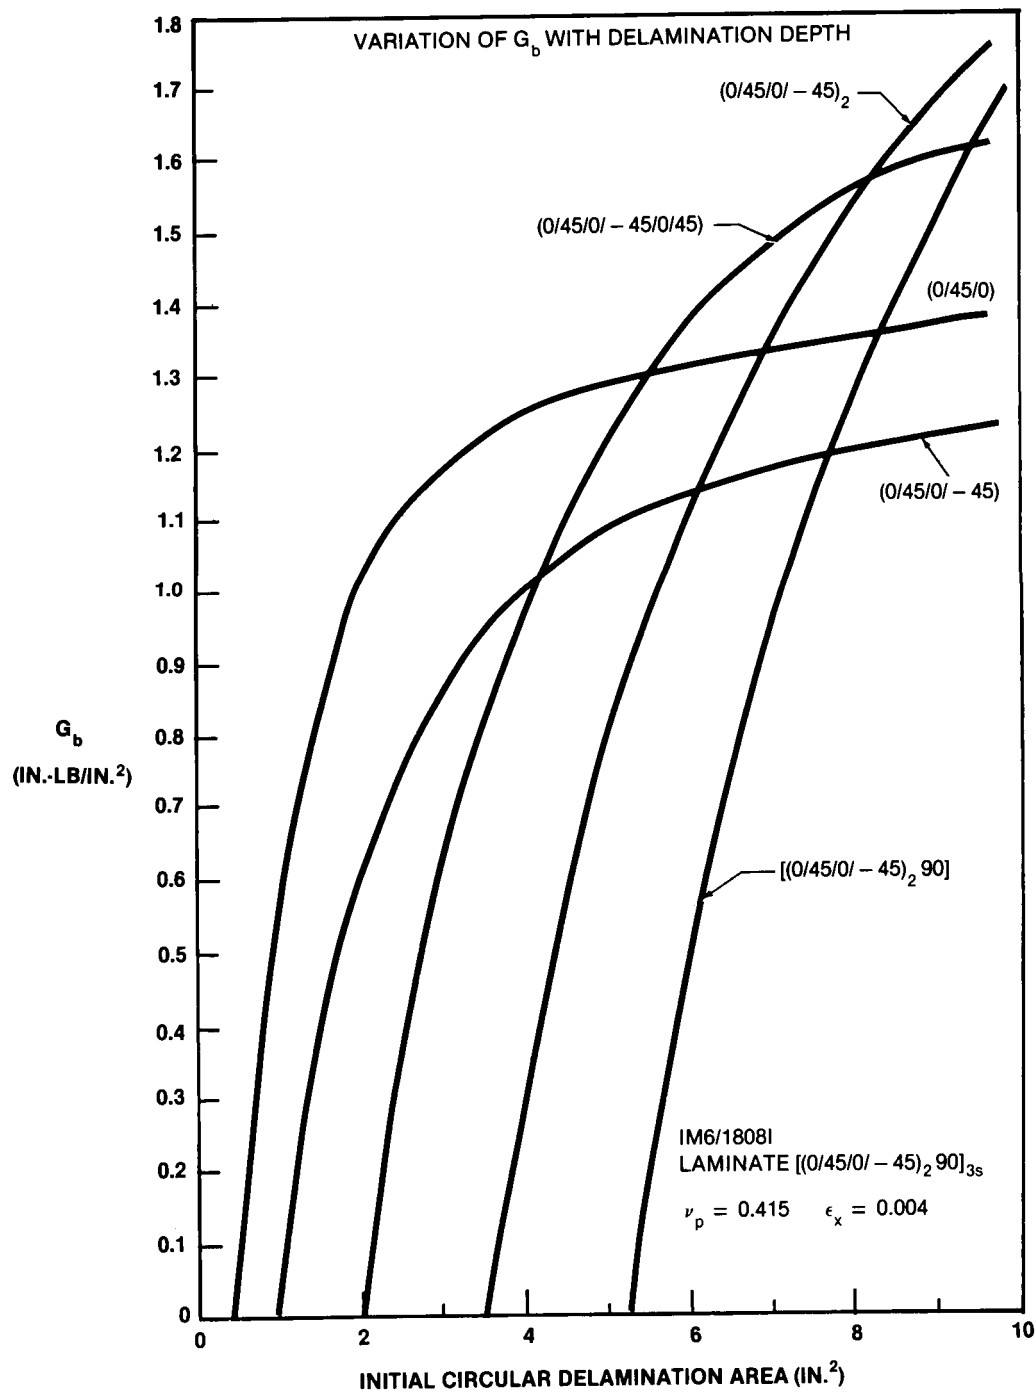
Figure 38. Sensitivity of Parameter  $G_b$  to the Depth of the Delamination Plane

The sensitivity of the parameter  $G_b$  to the depth of the delamination plane is shown in Figure 38. The effects can vary depending on the size of the initial delamination. However, for the size of impact damage likely to occur in the new toughened system, the deeper delaminations are generally less critical than those toward the surface.

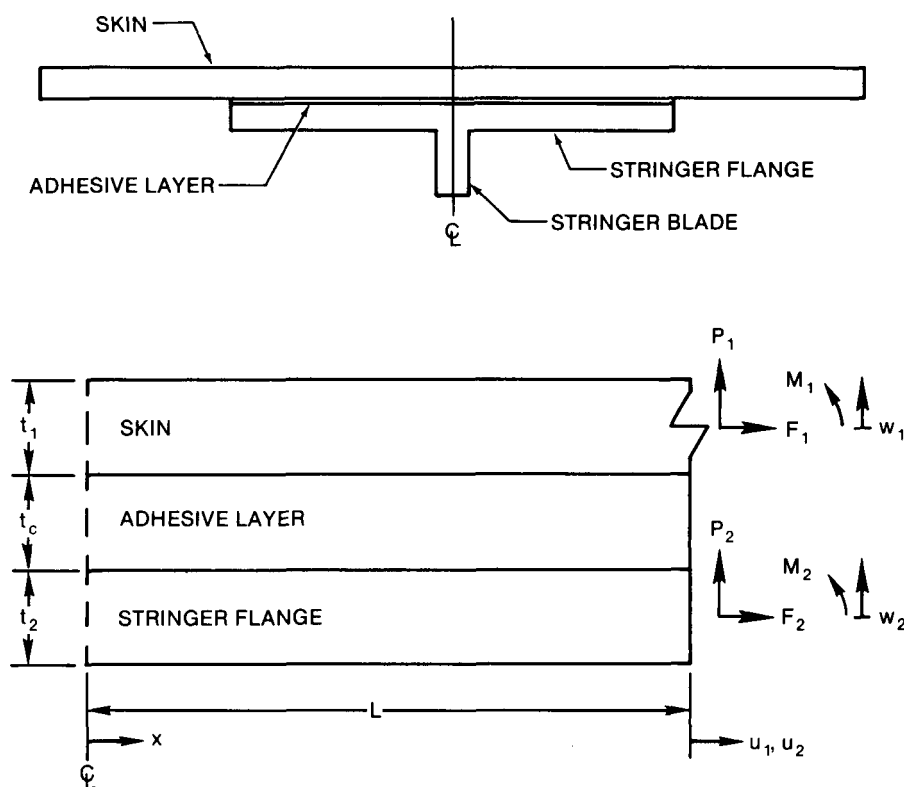
Figure 39. Model Used for Analysis

The model analyzed is shown in Figure 39. The upper and lower members are beams of unit width, and the effect of the stringer blade is disregarded. In this analysis, subscripts 1 and 2 refer to upper and lower beams, respectively, and subscript c refers to the adhesive. In addition to assuming beam behavior and small deflections, the adhesive is assumed to be linearly elastic and of constant thickness. The restraint on the adhesive provided by the two beams prevents Poisson's contraction, making the assumption of linear elasticity a reasonable one.

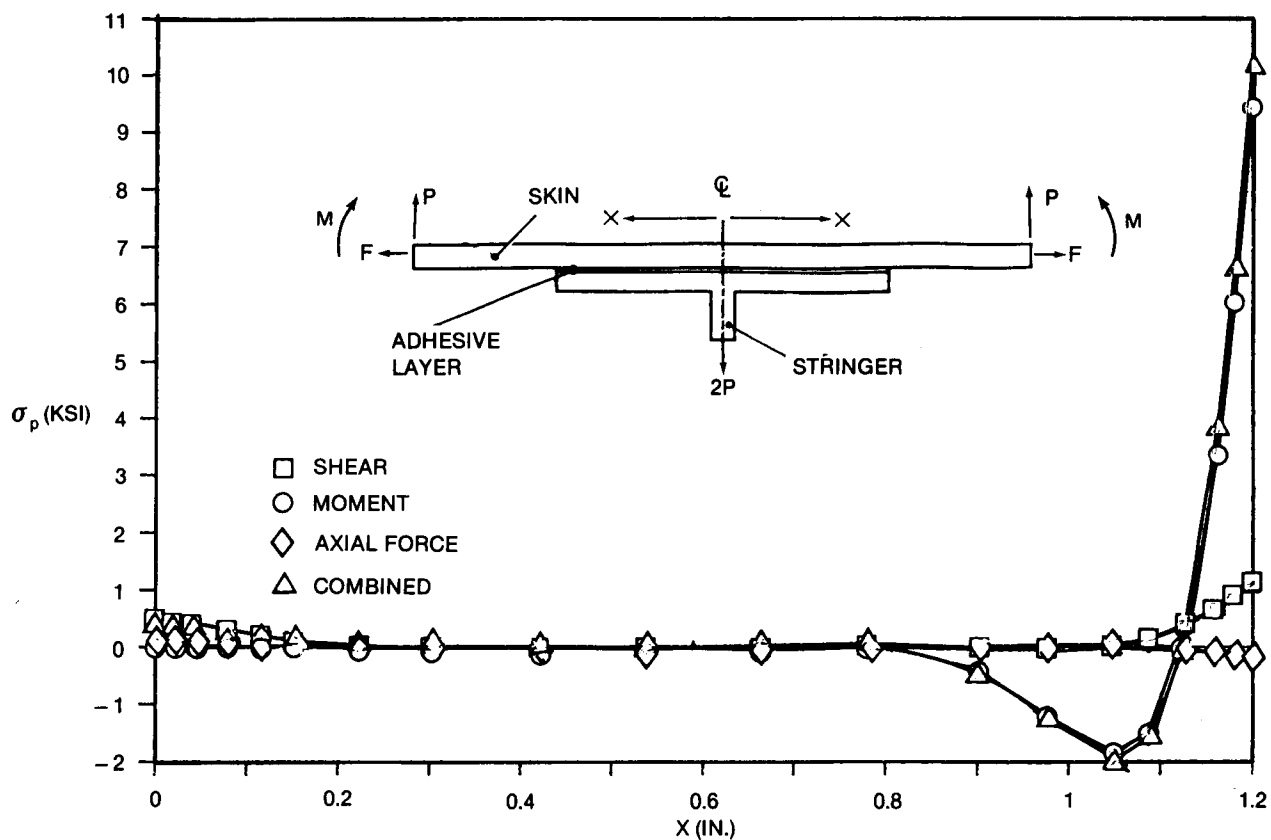
Figure 40. Peel Stress Distribution

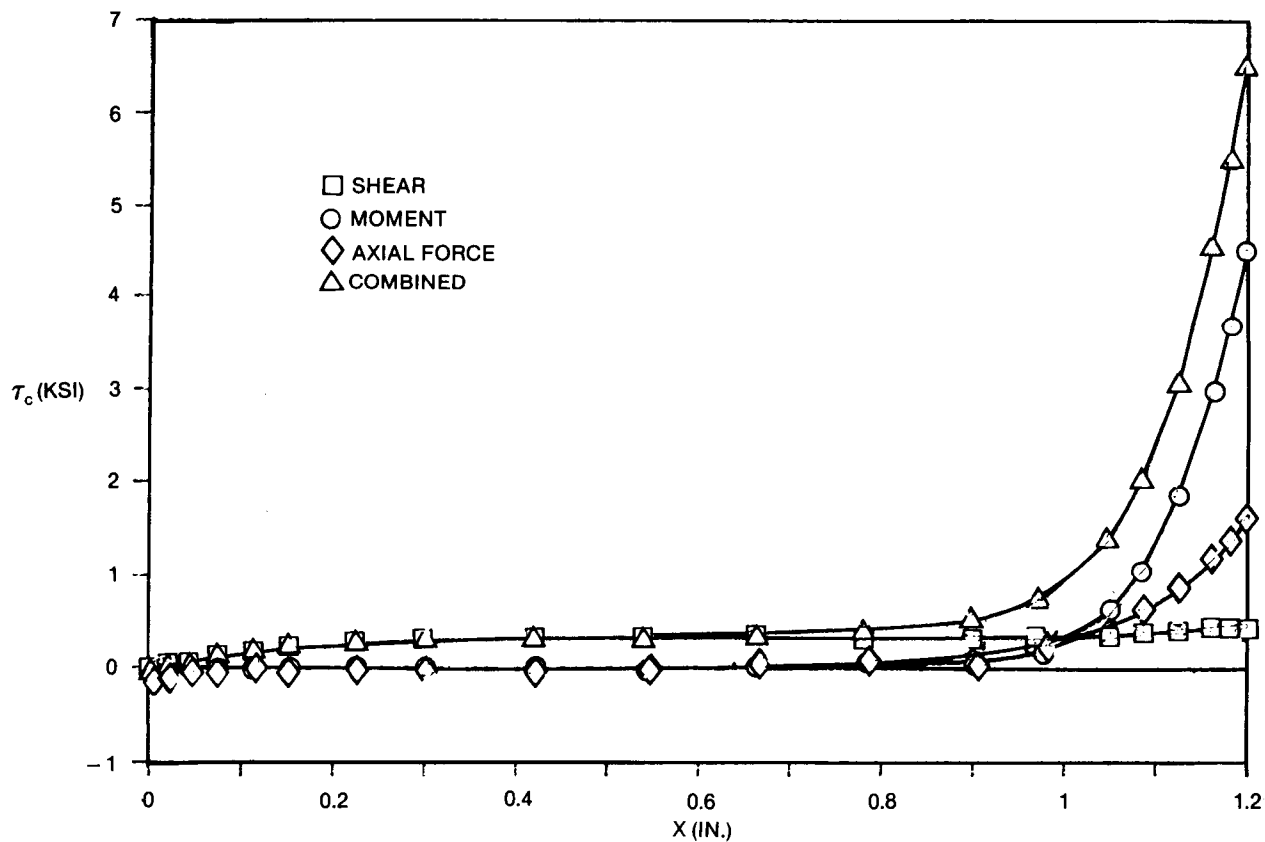
Figure 41. Shear Stress in Adhesive Layer

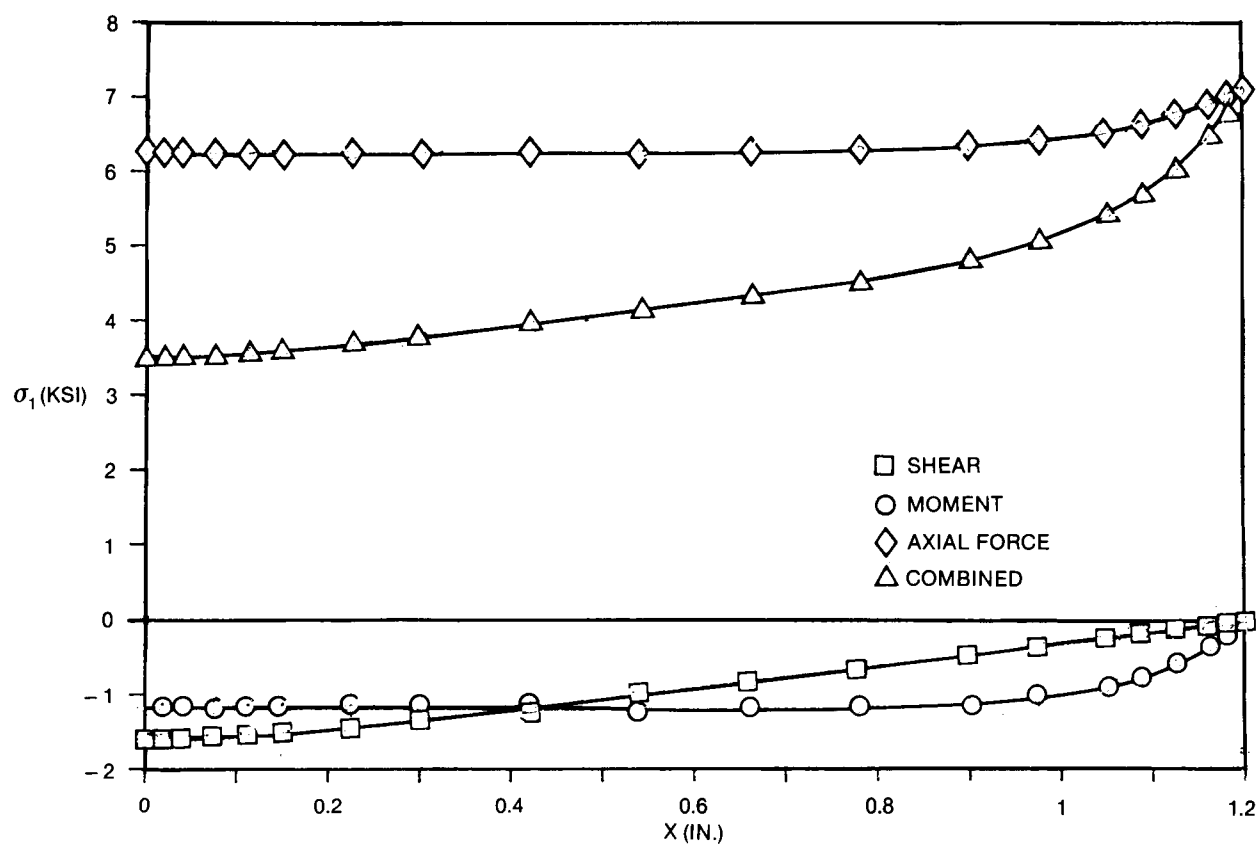
Figure 42. Axial Stress in Skin (Upper Plate)

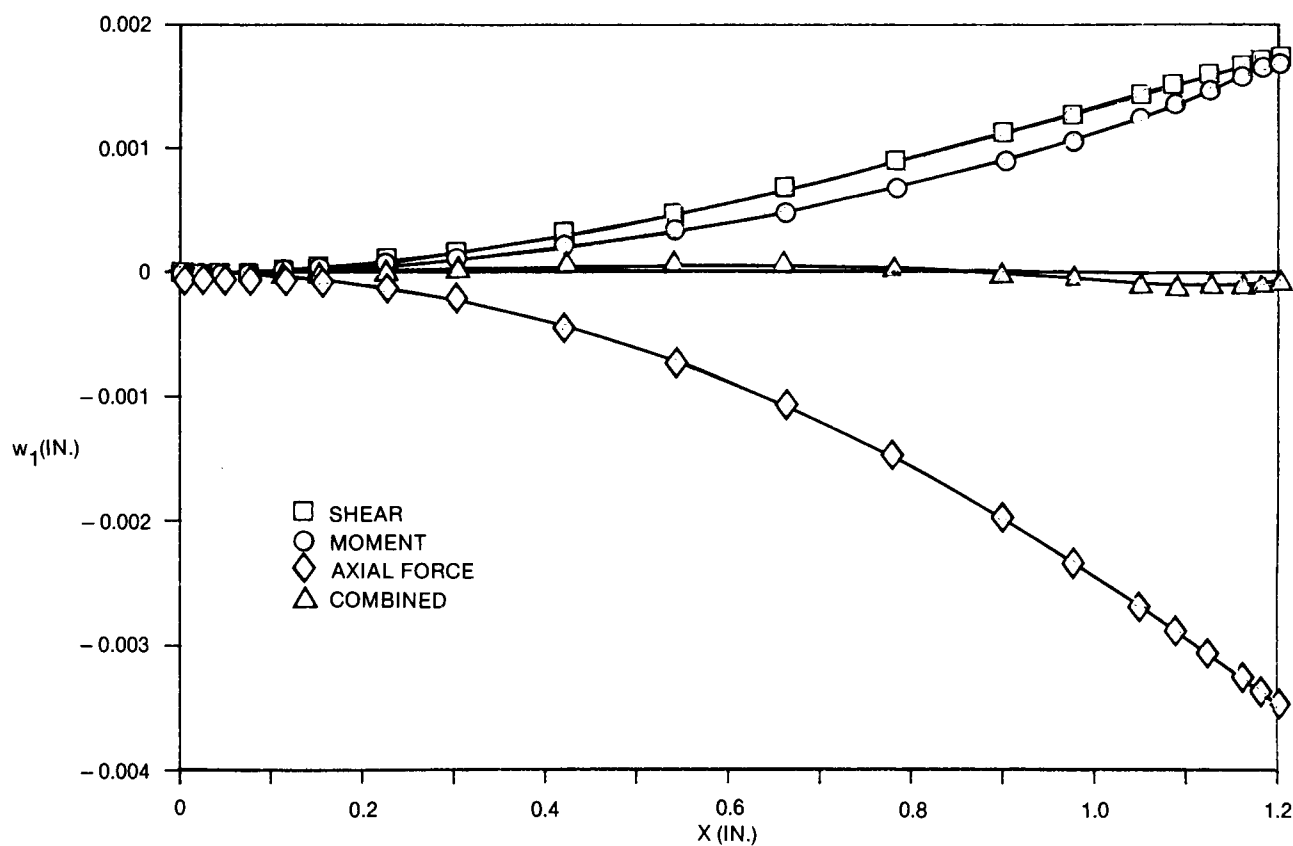
Figure 43. Out-of-Plane Deflection of Skin (Upper Plate)

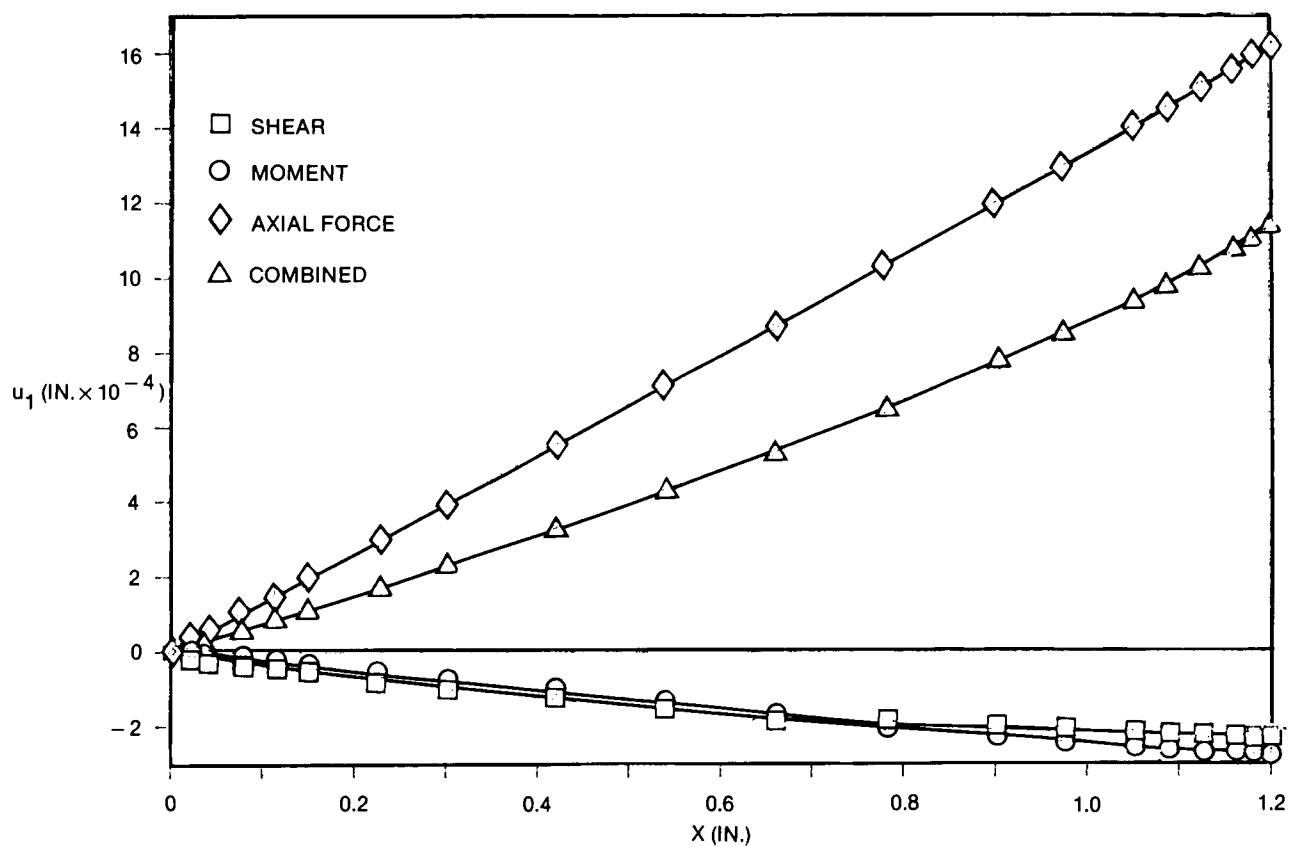
Figure 44. Axial Displacement of Skin (Upper Plate)
